BECAUSE FIRST IMPRESSIONS COUNT

Tray Seating

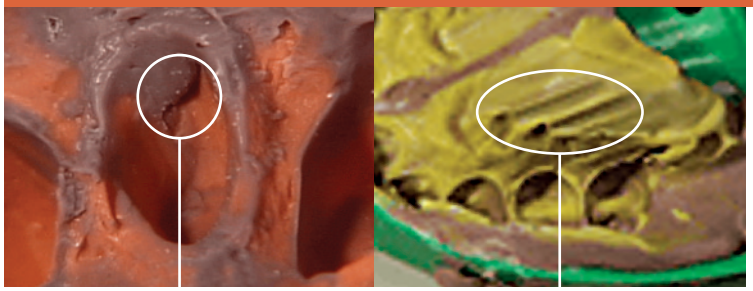
Photo #1 Ledges *Photo #2 Drags*

Issue	Cause	Solution
Ledges. *(photo #1)*	Rapid tray seating.	Position the tray before seating. Use a slow, steady, vertical seating motion to allow for blending of tray/wash materials.
Drags. *(photo #2)*	Placing and seating the tray in the mouth in one motion.	Carefully position the tray before seating. Once positioned, seat the tray vertically.
Delamination (poor blending and adhesion of wash to tray material).	Failure of the impression material to adapt to the teeth.	Seat the tray slowly.
	Teeth rebounding off the tray and sliding into position.	Avoid contact of teeth with tray.
Slanted or wavy teeth.	Tray movement after seating.	After tray seating, use passive pressure to immobilize the tray for the full recommended oral set time.
Rocking crown.		
Short crowns.	Teeth in contact with tray and/or not adequately relieving pre-set impression material.	Avoid contact of teeth with tray or pre-set tray material.
